Possible causes to TV reception;

How to install a Ferrite core to cable

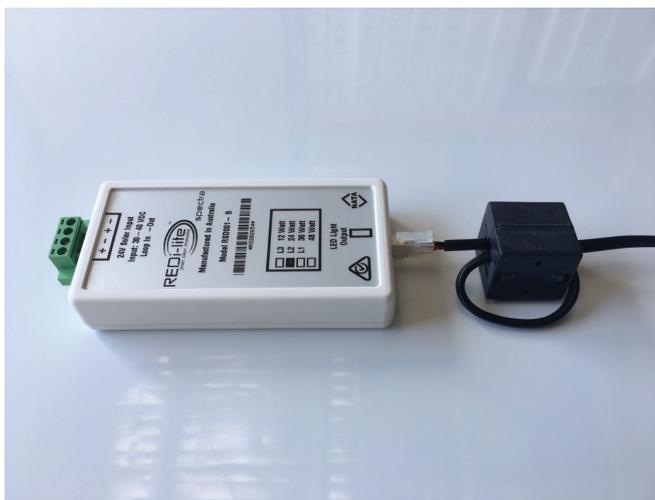
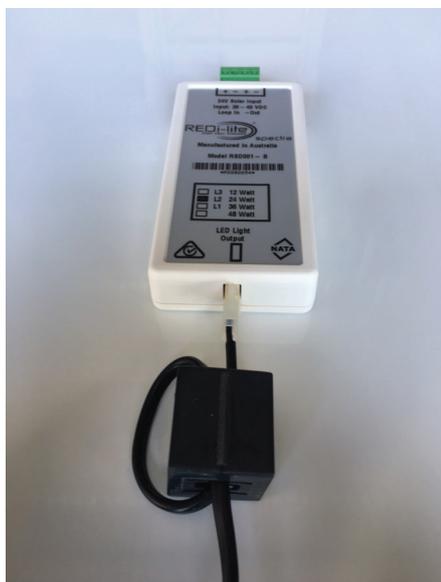
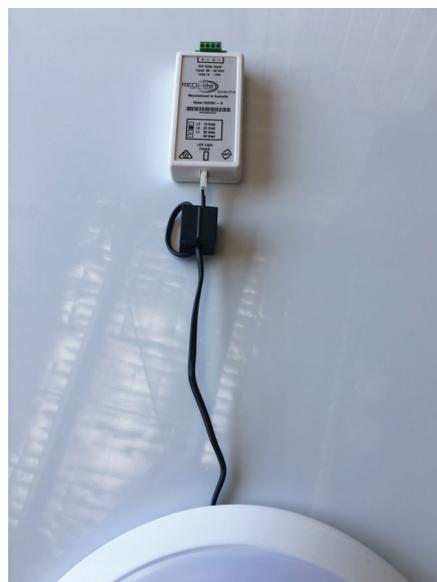
In below average TV reception areas a booster is sometimes required which can at times pick up interference from the Redilight driver and boost it which will interfere with the TV reception.

1. TV aerial cables or booster are too close to a Redilight light driver, within a couple of metres.
2. Coaxial cables running over or near the Redilight light driver.

1. Move Redilight light driver a minimum of 5m away from TV booster.
2. Install a Ferrite core around cable on load side of driver (light fitting cable).

Open up the Ferrite core and pass the light fitting cable through twice then close.

Note: The Ferrite core is installed on the load side of the driver (light fitting cable)
